Lake Anasagunticook Watershed Survey Report 2019

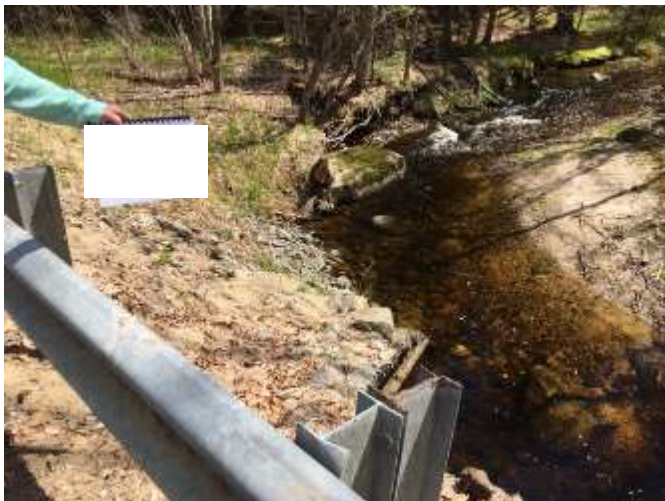
This **high** impact town road site has gully erosion, a steep slope and sand flowing directly into the stream. Suggested remediation includes enlarging and lengthening the culvert and cleaning out plunge pool; installing turnouts for ditches; diversion or curb at the culvert and removing grader/plow berms. Paving is scheduled for spring which may help.

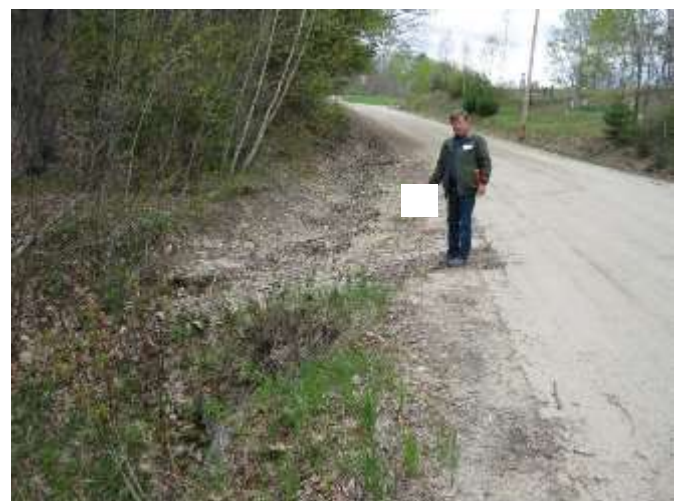
This **low** impact town road site had rill surface erosion and rill road shoulder erosion on a moderate slope. Suggested remediation is to armor the inlet/outlet of the culvert and armor ditch with stone.

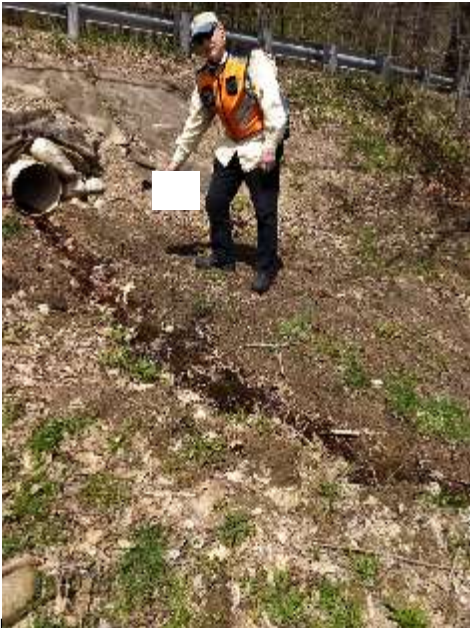
This **high** impact residential site has gully ditch erosion and bare soil on a moderate slope and flows directly into the lake.

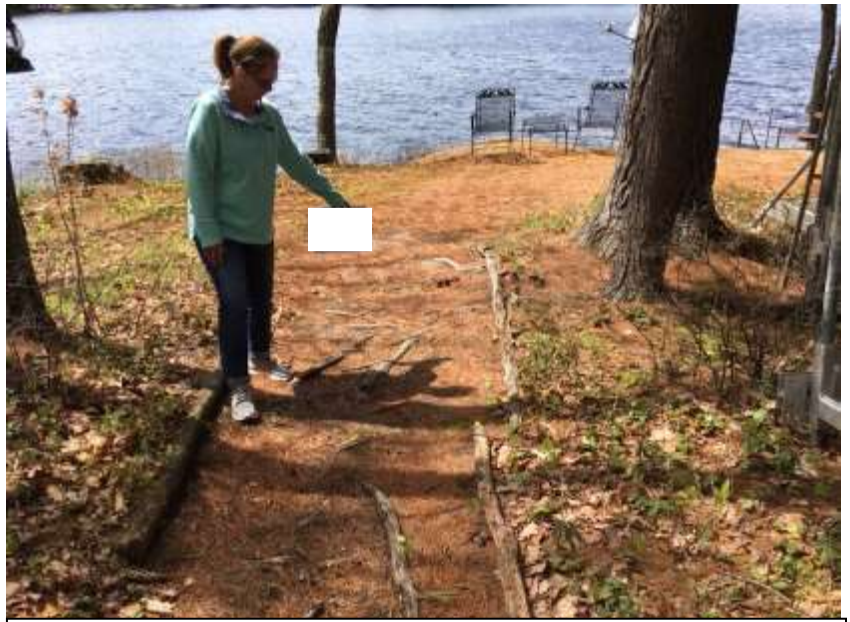
This **low** impact residential site has sheet surface erosion, exposed roots, a steep slope, and flows directly into lake

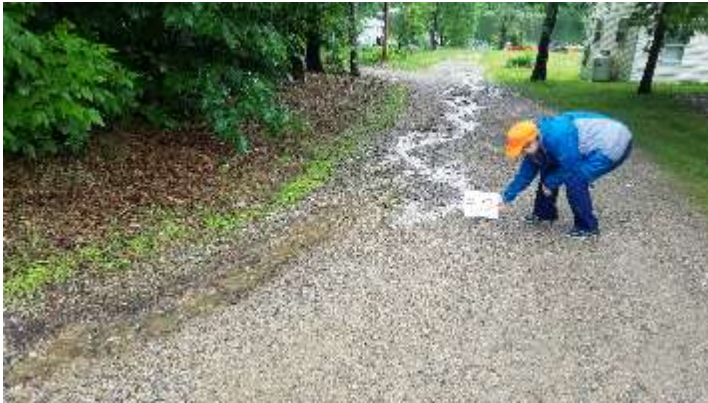
This **high** impact private road has sheet surface erosion, sheet erosion in a ditch, bare soil, and a steep slope directly to the lake

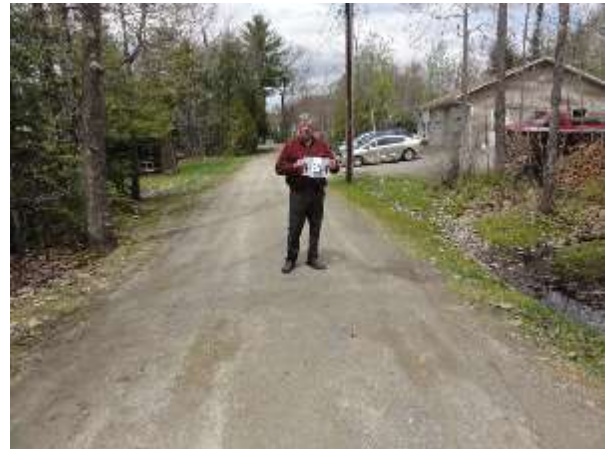
This **low** impact private road has sheet and rill surface erosion and stream flow into the lake

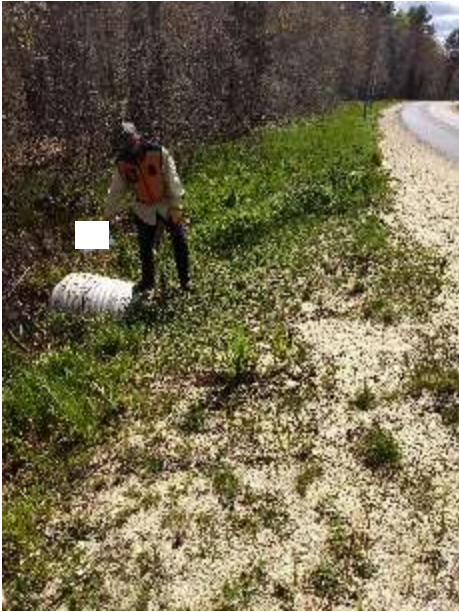
This **high** impact state road has a clogged culvert with an unstable inlet/outlet with a moderate slope and flows to the lake via a stream

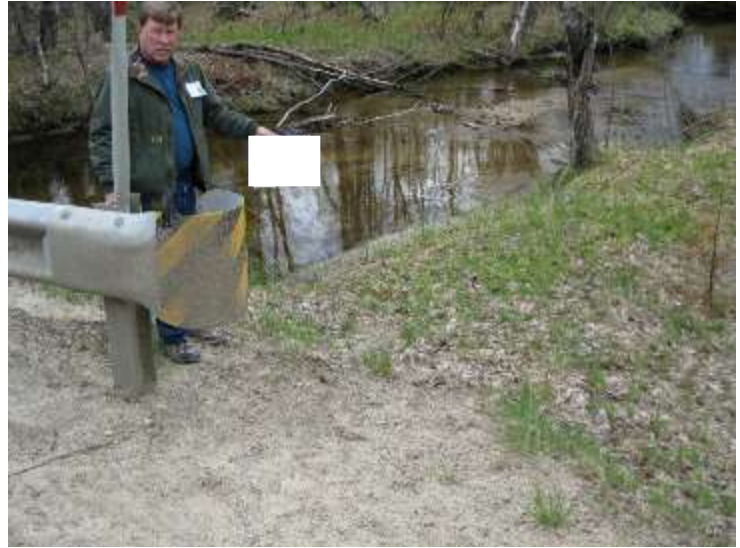
This **medium** impact state road has rill surface erosion; rill road shoulder erosion, a flat slope, and flows to the lake via a stream

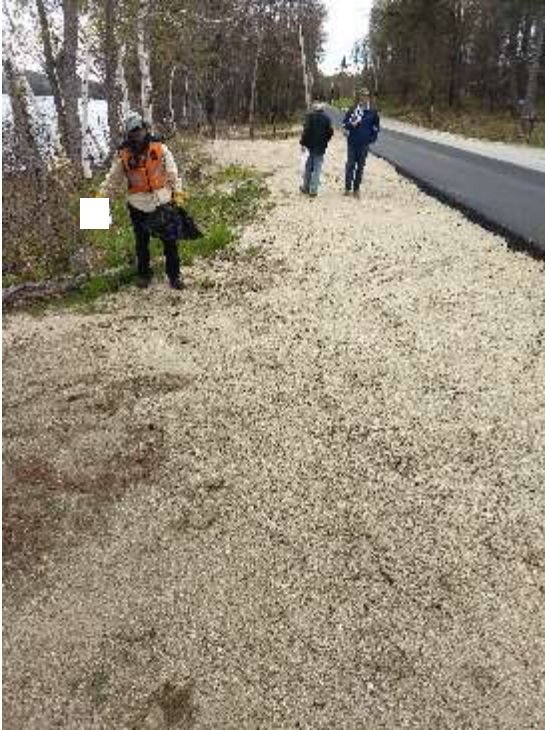
This **high** impact beach/ road shore site has rill and gully surface erosion, rill and gully road shoulder erosion, bare soil, a delta in the lake/stream, winter sand , a lack of shoreline vegetation and a moderate slope with flow directly into the lake

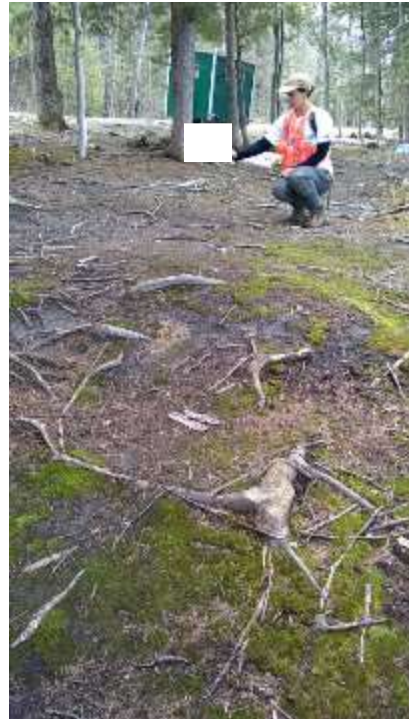
This **low** impact beach/ road shore has sheet surface erosion, bare soil, flat slope, and flows directly into lake

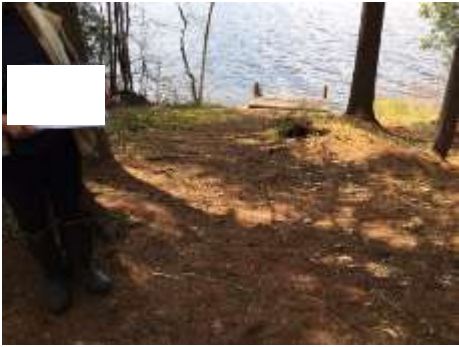
This low impact path has sheet surface erosion, inadequate shoreline vegetation, a steep slope, and flow runs directly into the lake

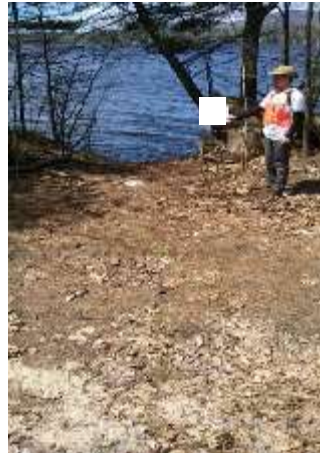
This low impact municipal property has sheet erosion, bare soil, unstable access to shoreline, and a moderate slope that flows directly into the lake
